**RE: Test Pit Summary Report
Thorndike Place Stormwater Peer Review**

TEST PIT SUMMARY REPORT

**THORNDIKE PLACE
DOROTHY ROAD
ARLINGTON, MA**

JULY 2023

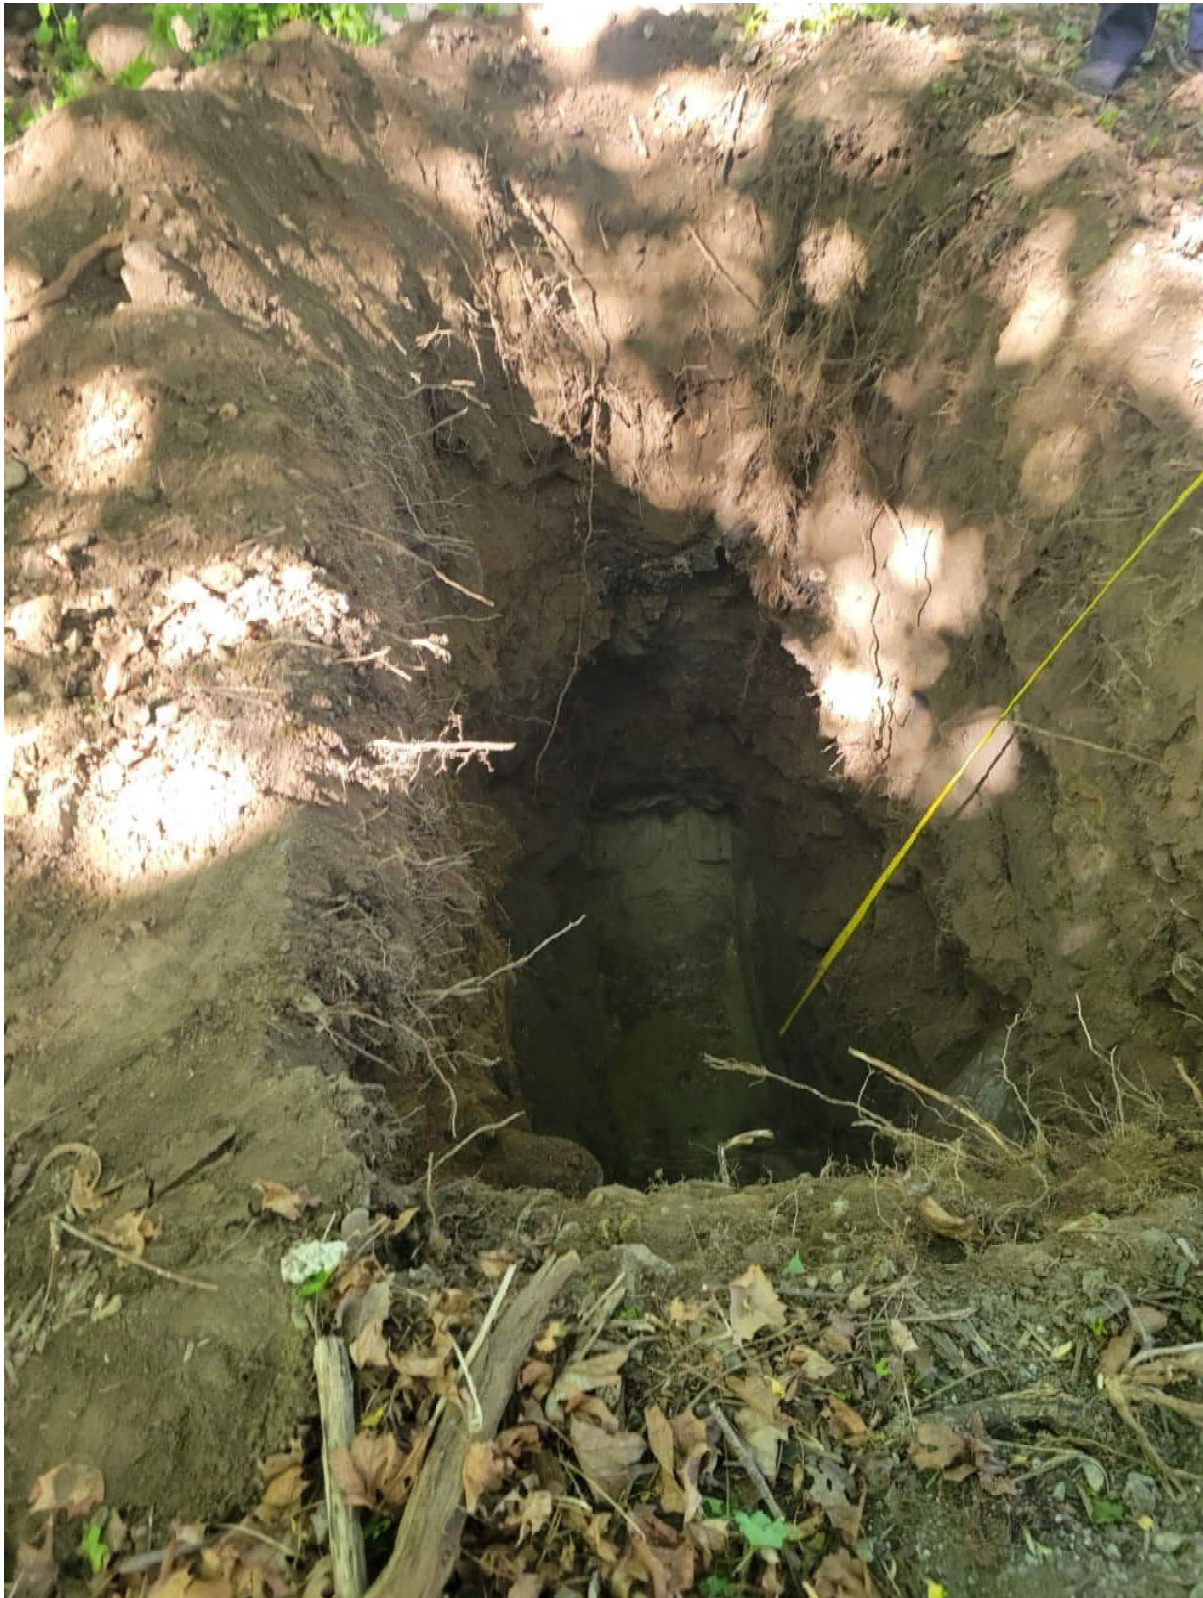
TP-1 at full depth

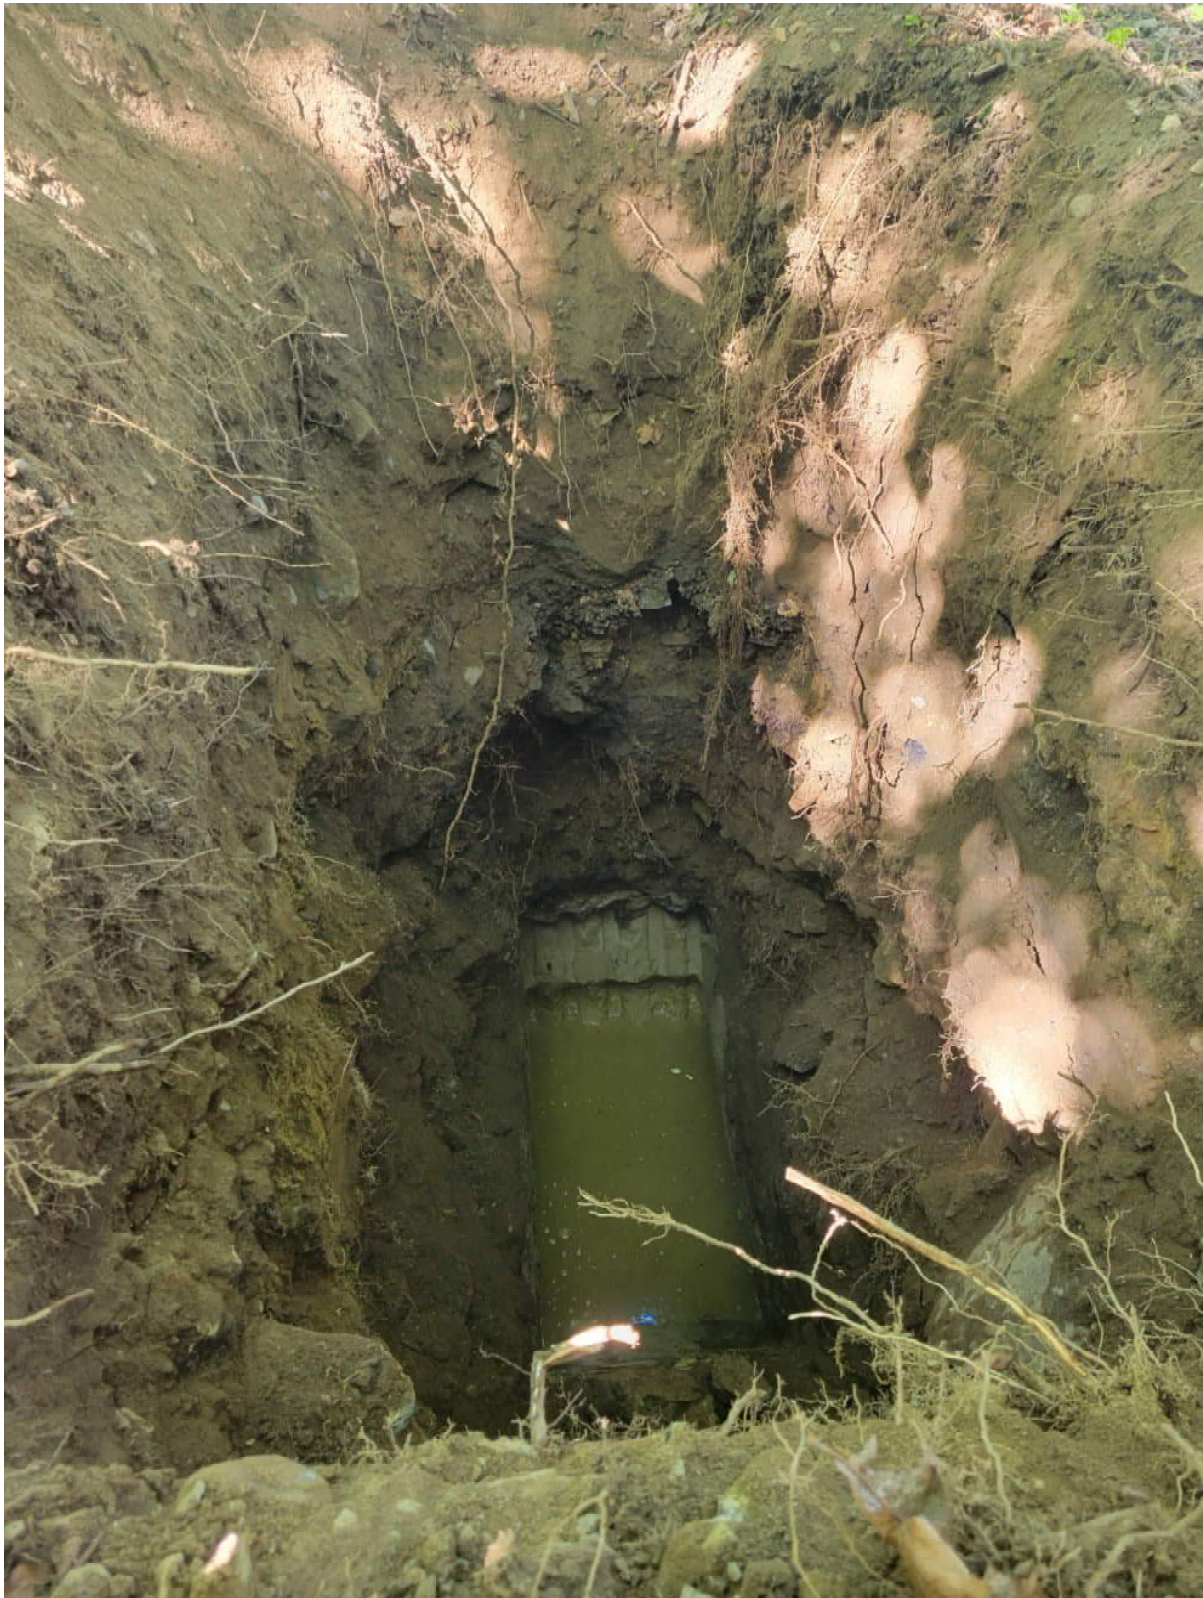
TP-1 with standing water at bottom

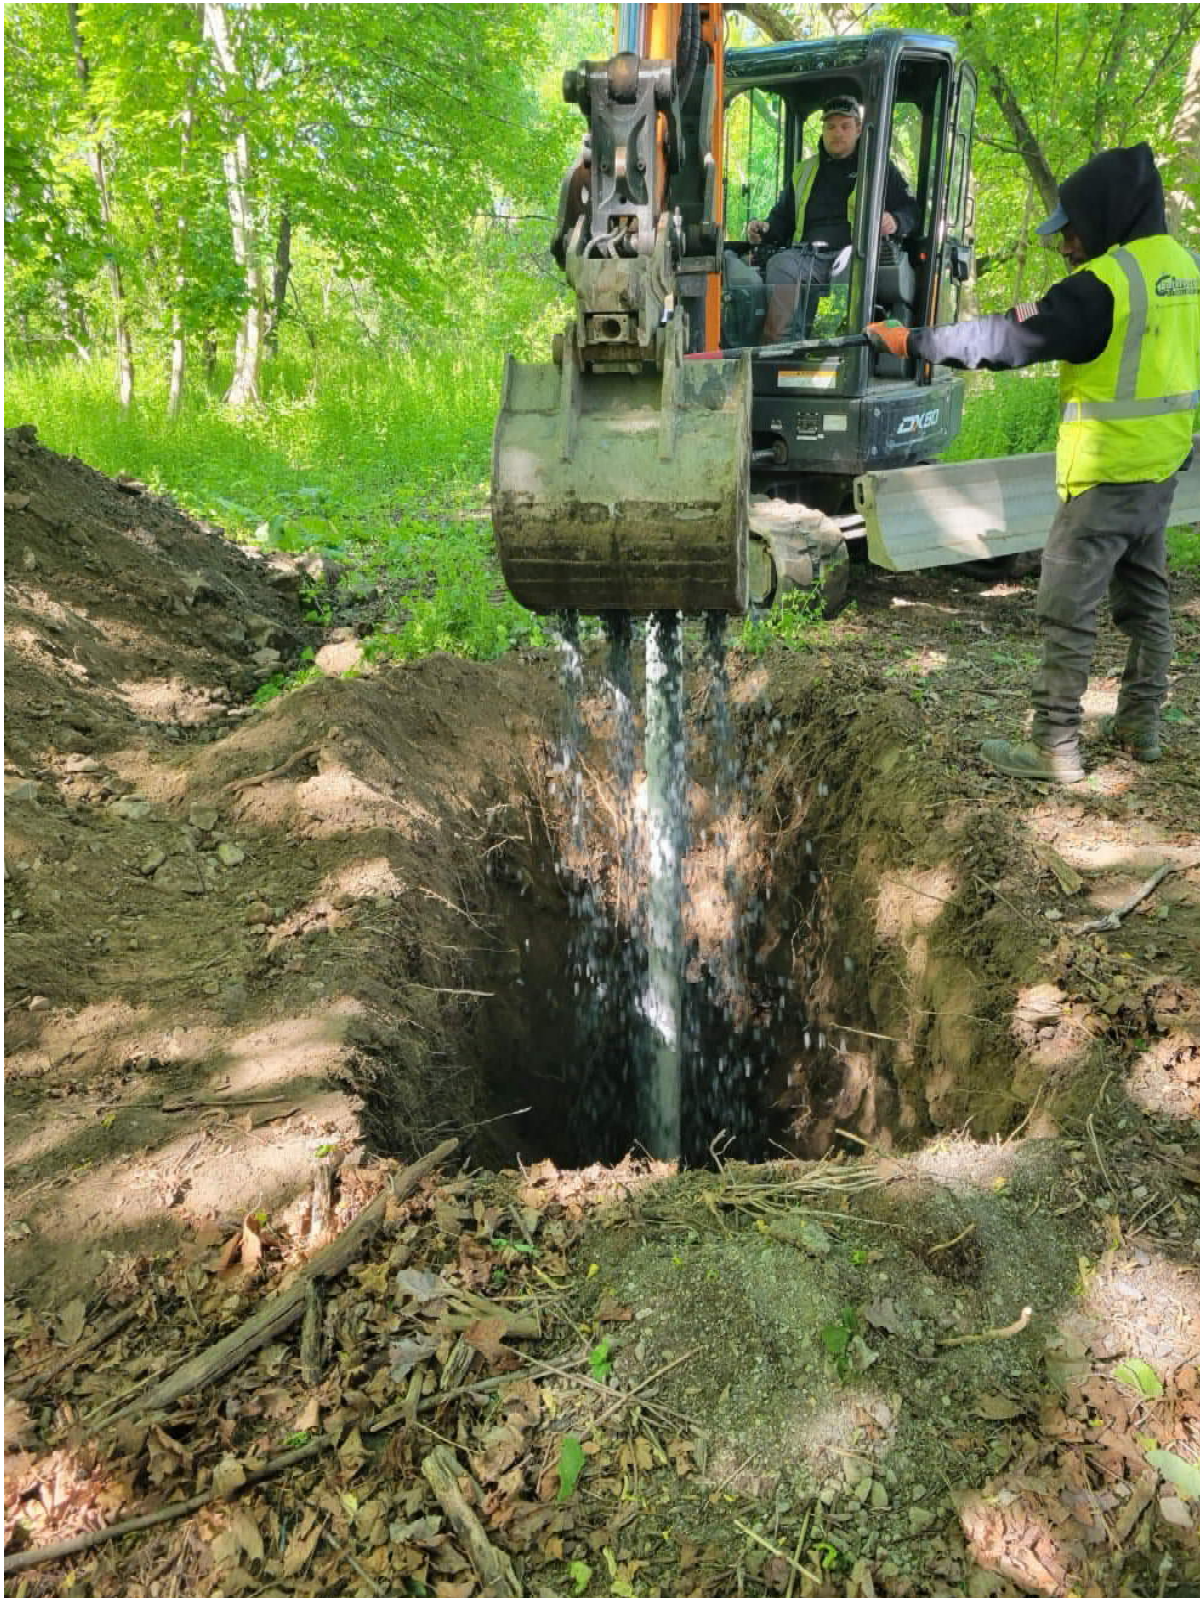
Installation of monitoring well at TP-1

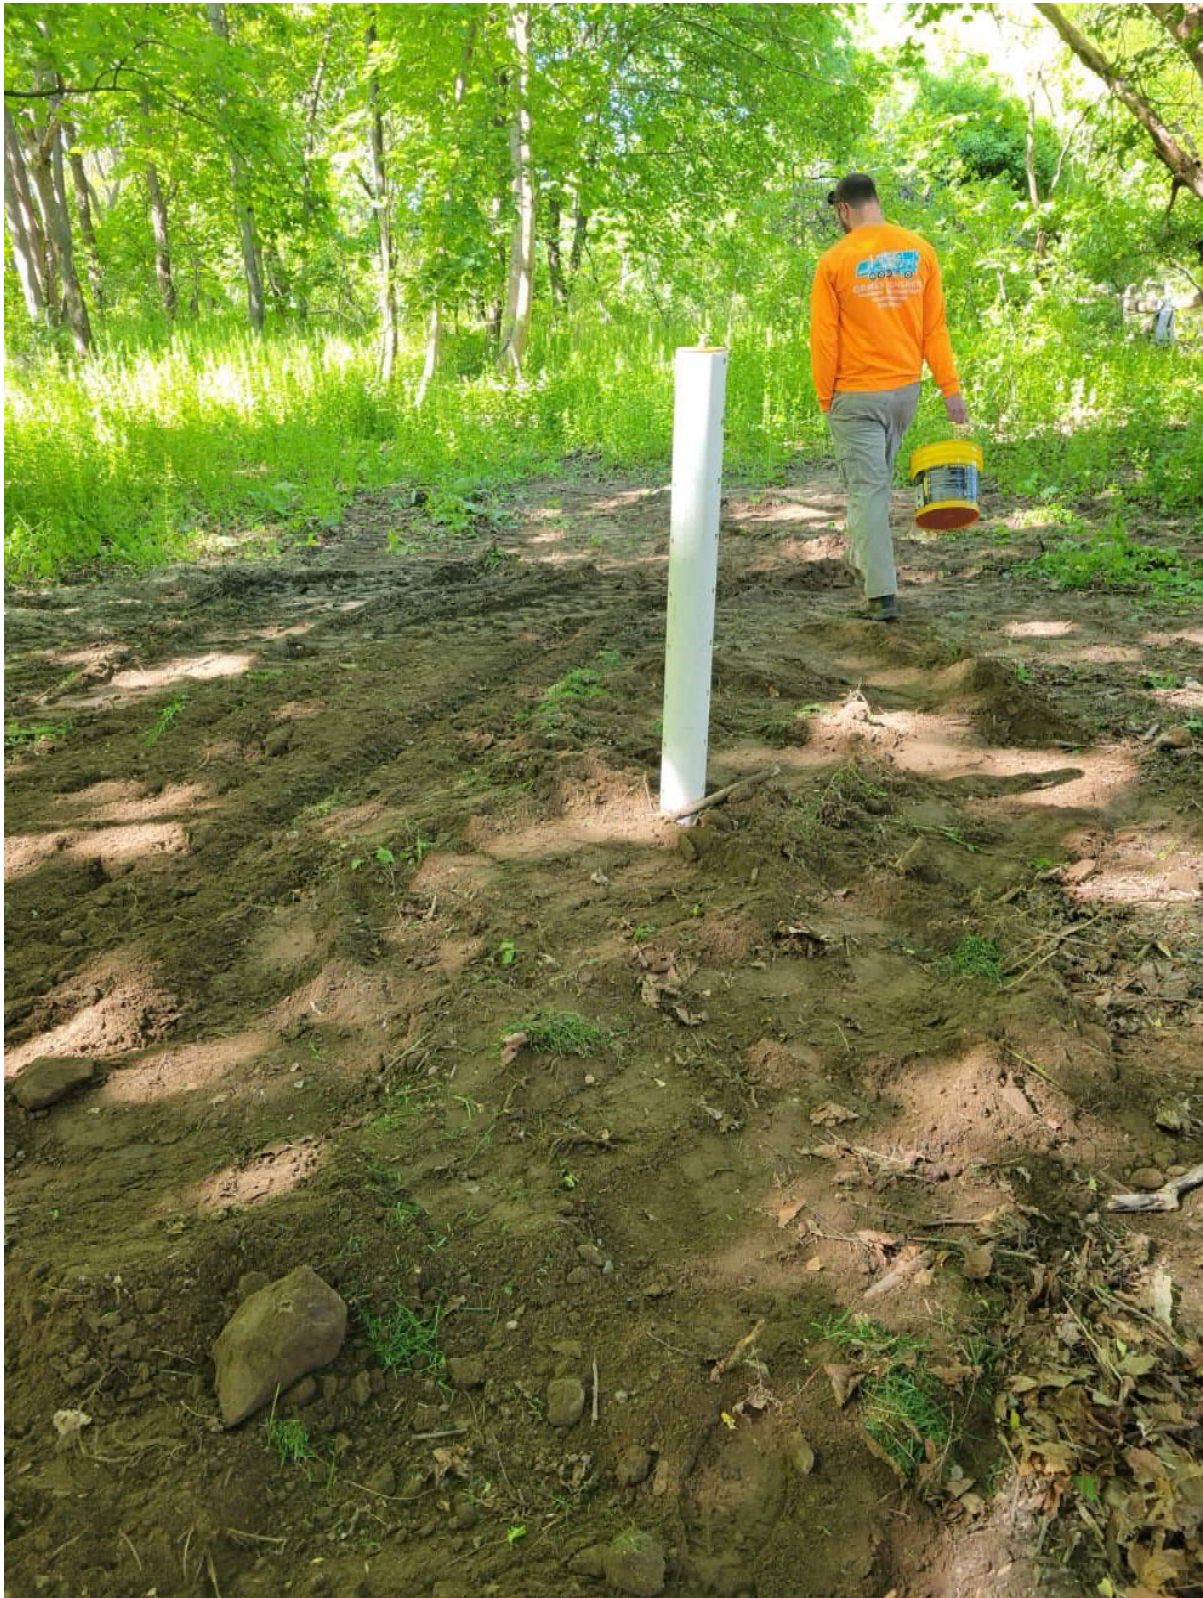
Completed monitoring well at TP-1

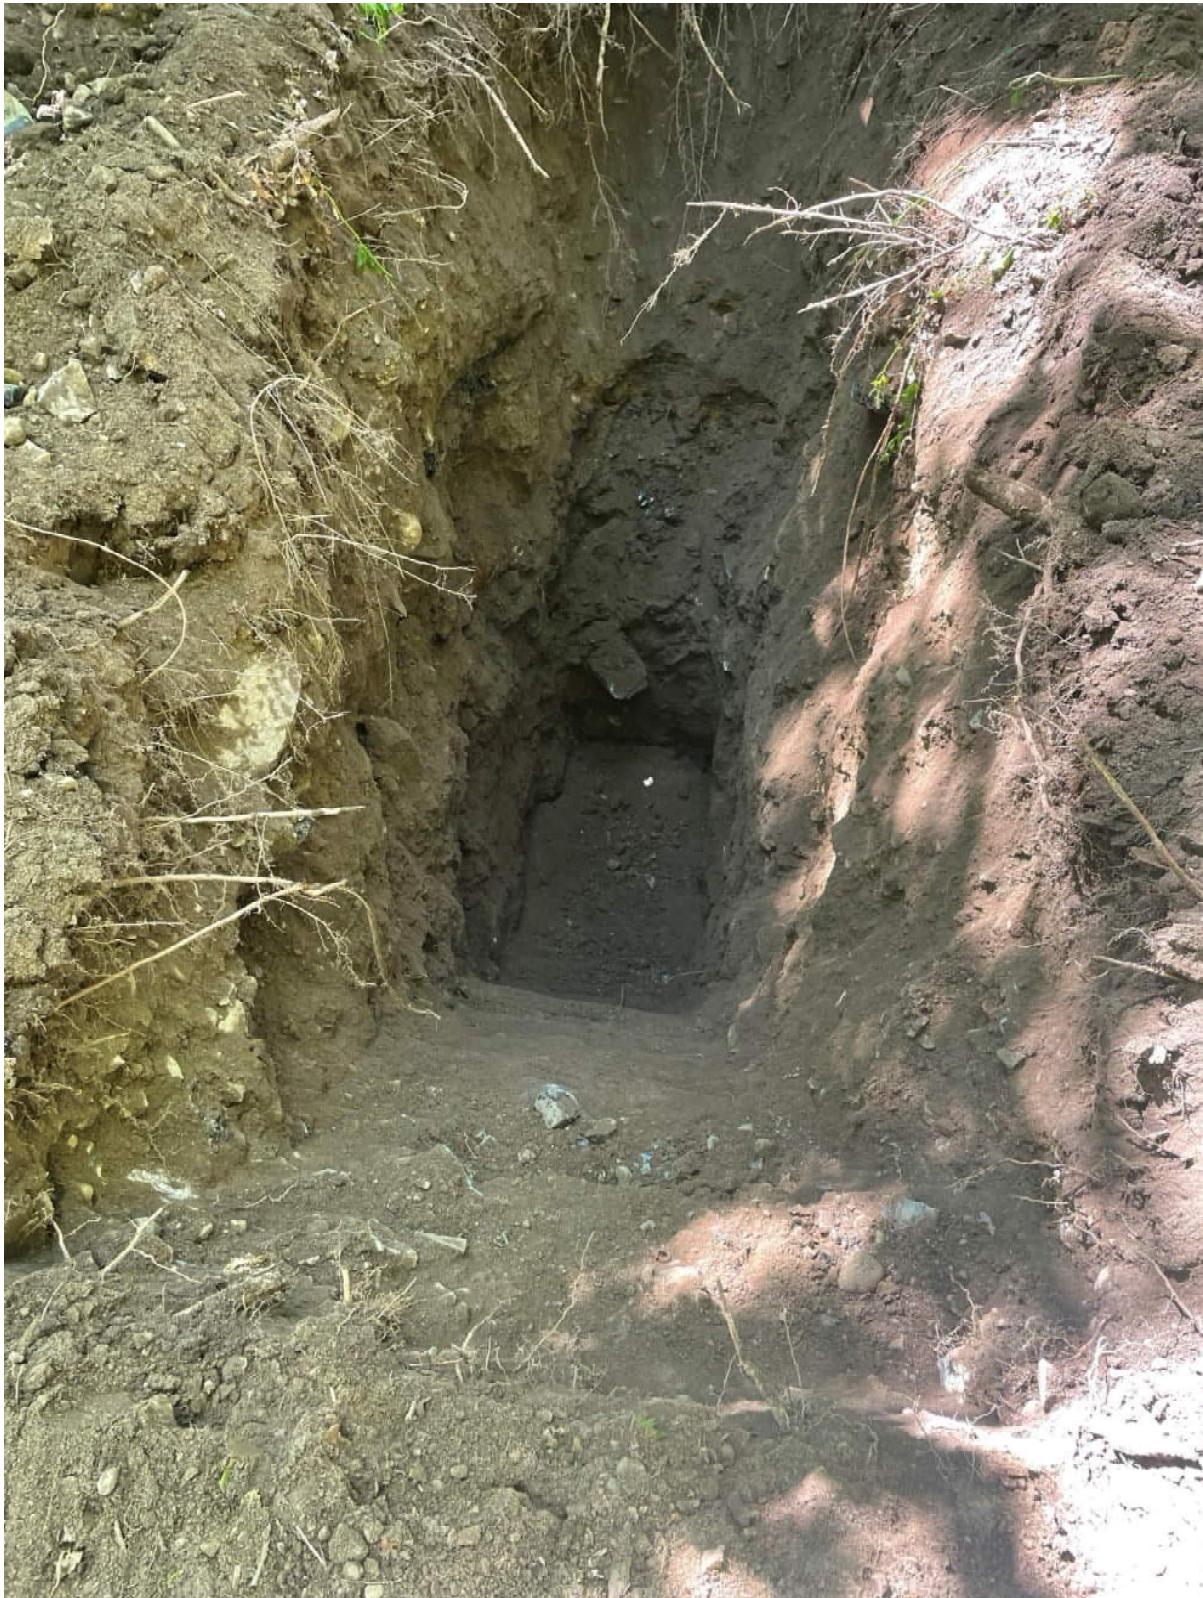
TP-2 at full depth

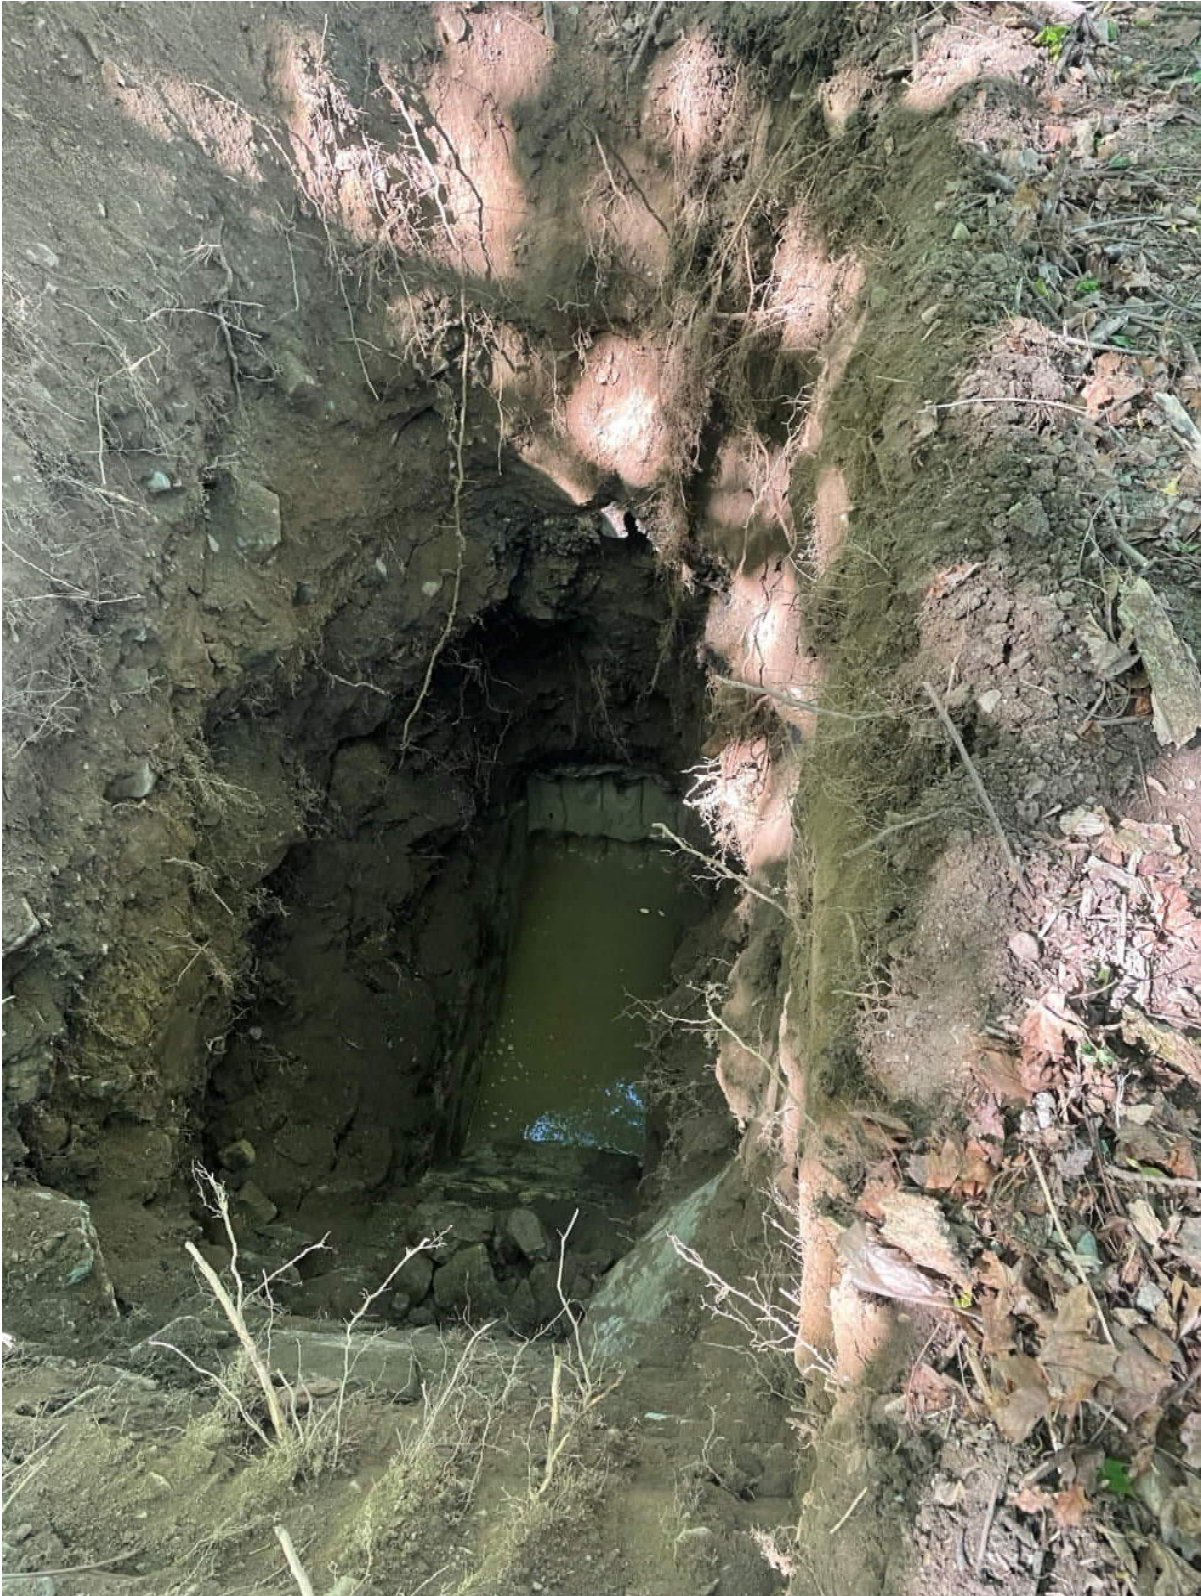
TP-2 with standing water at bottom

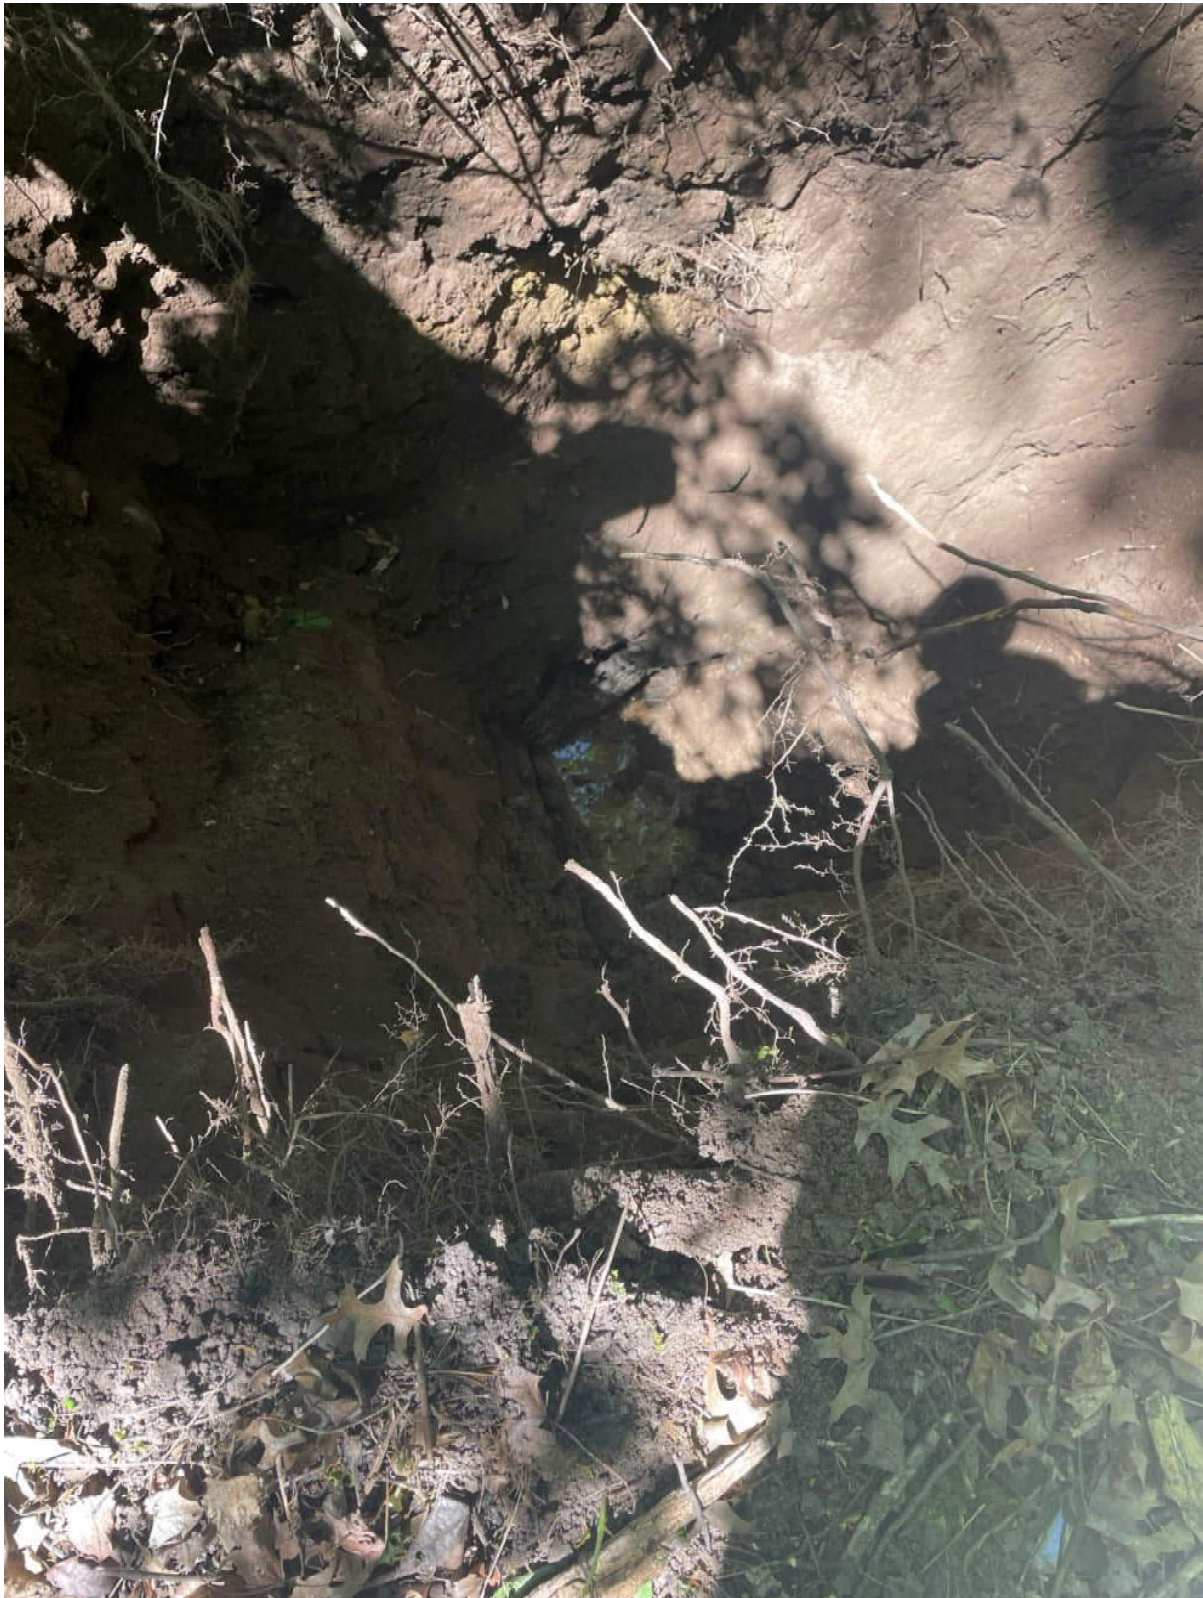
TP-3 with standing water at bottom

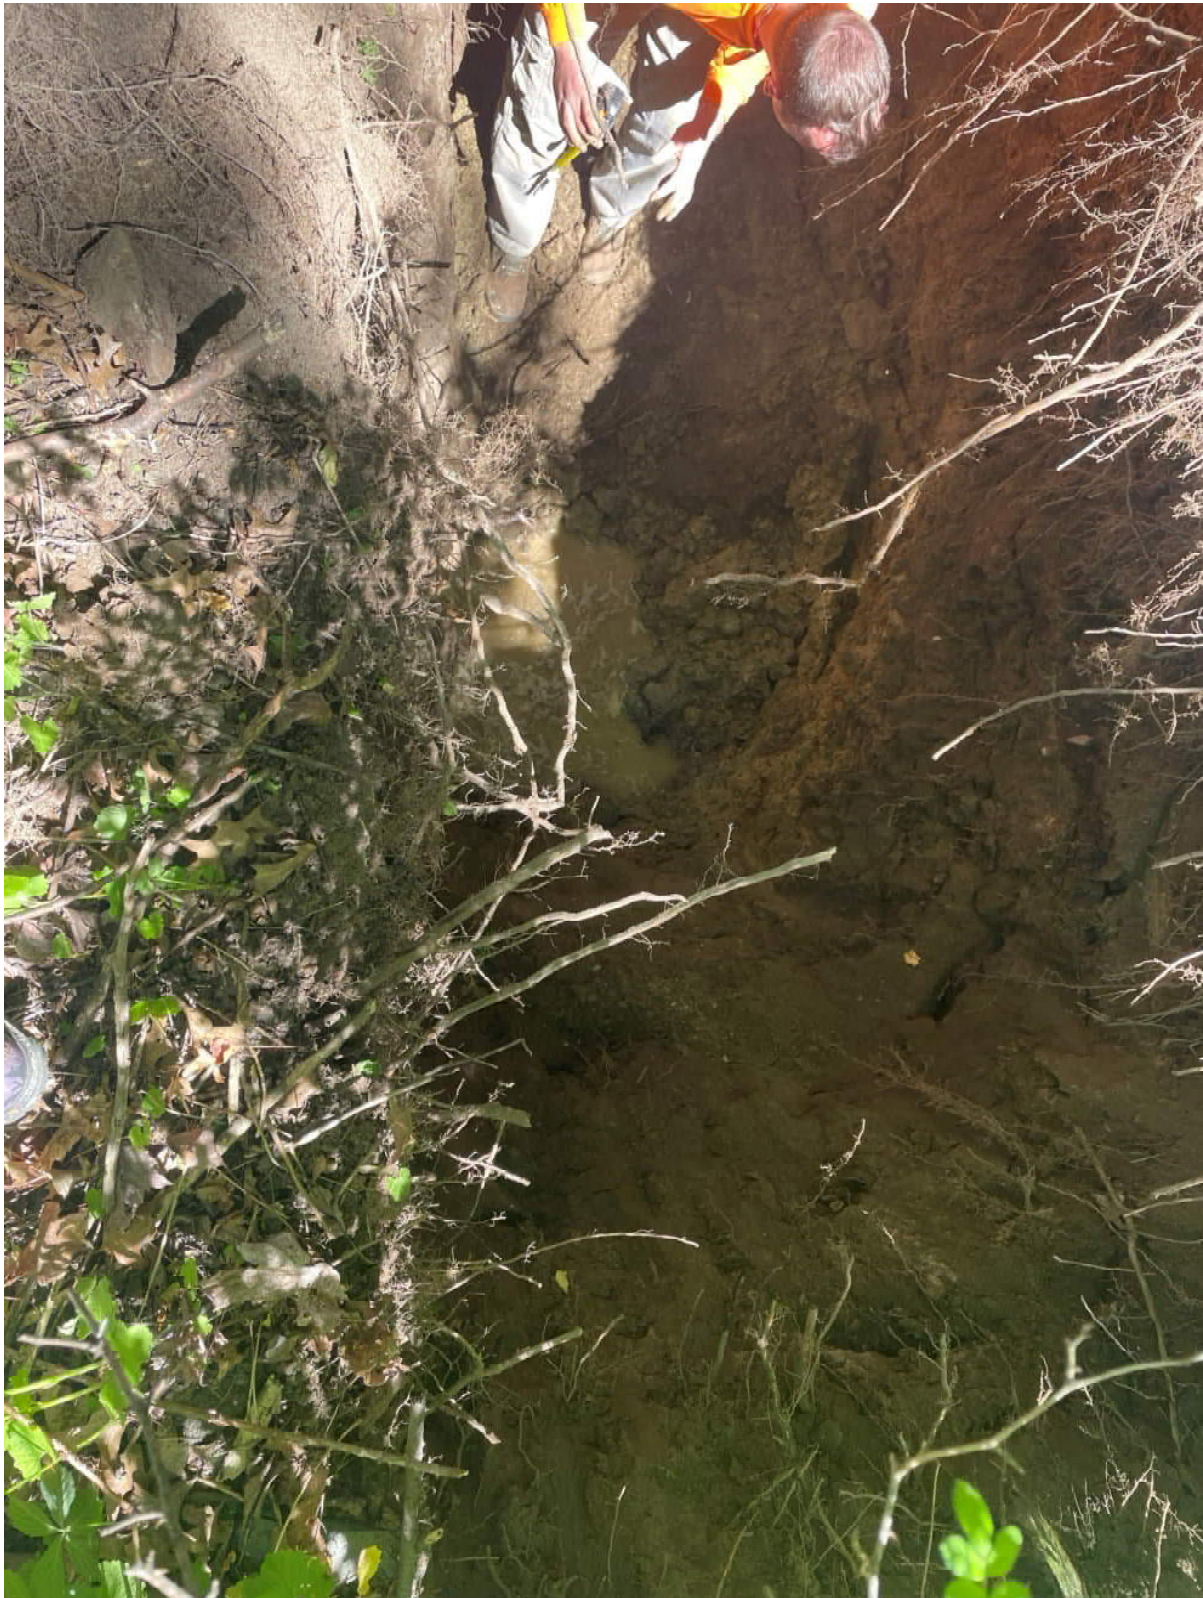
TP-3 with standing water at bottom. Note redoximorphic features on side wall.

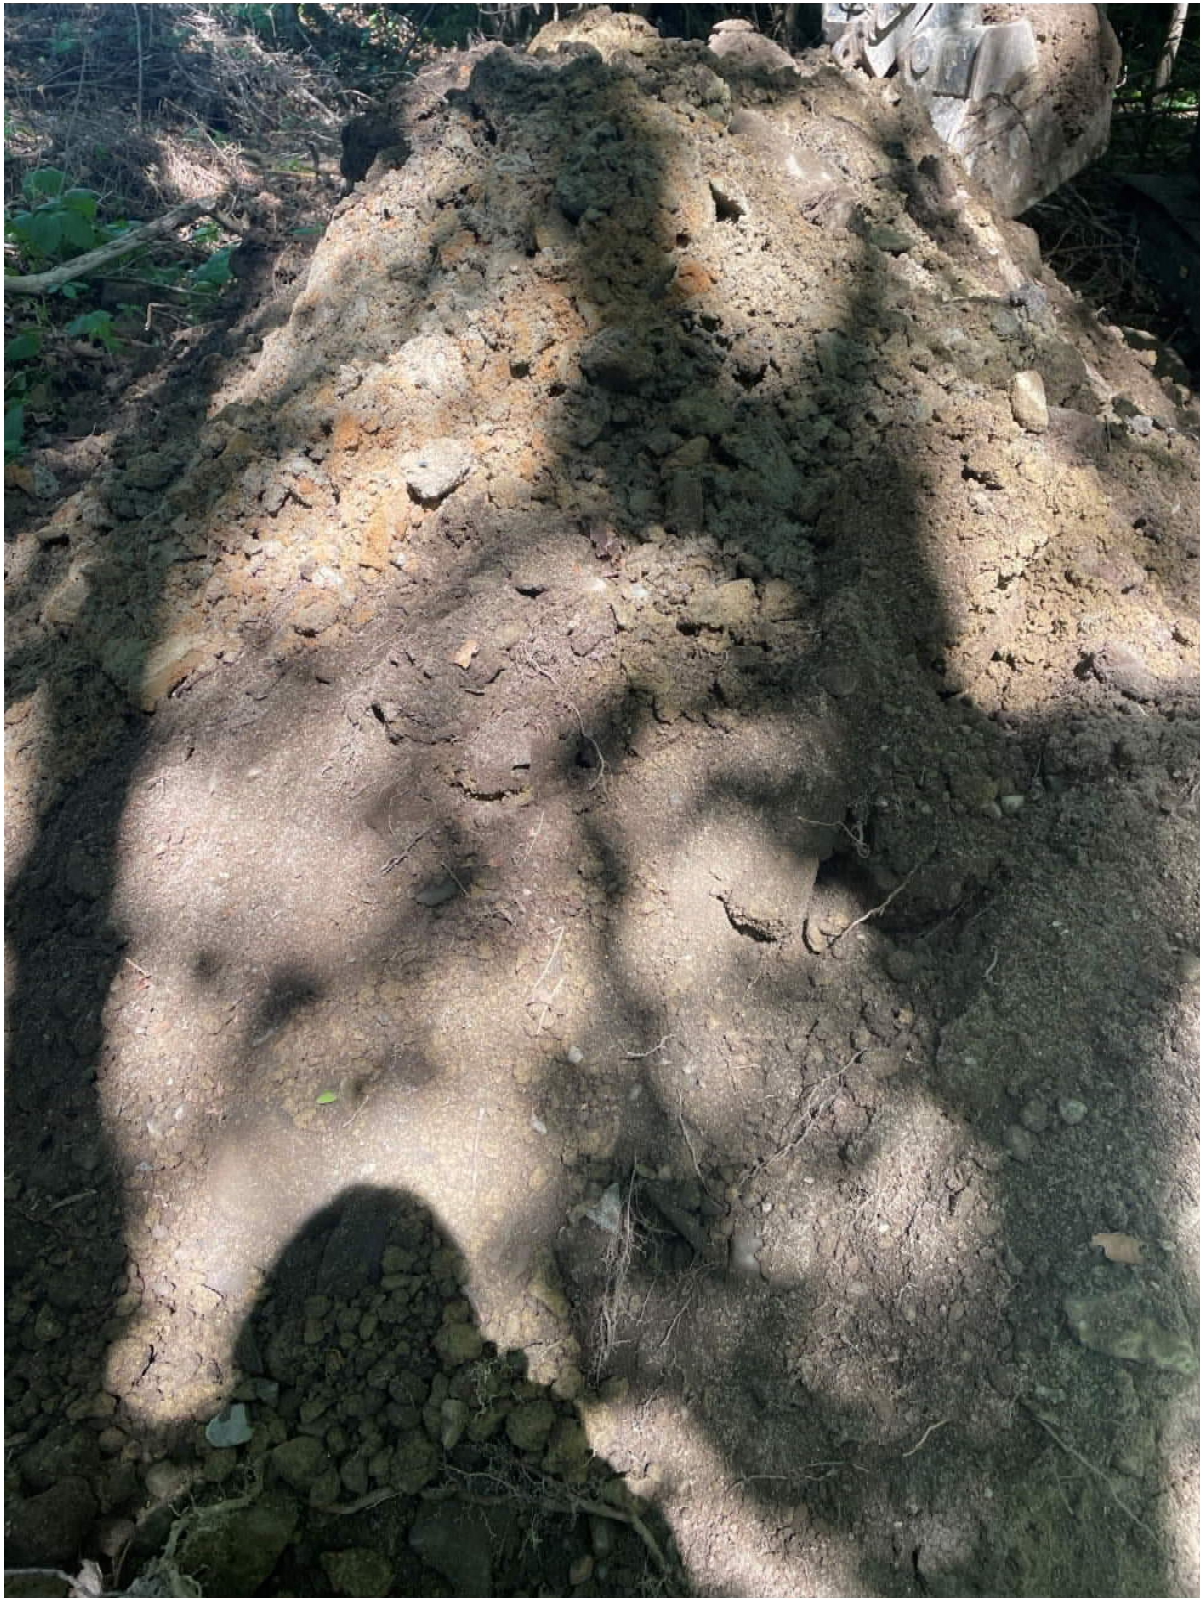
Soil pile from TP-3. Note redoximorphic features in soils.

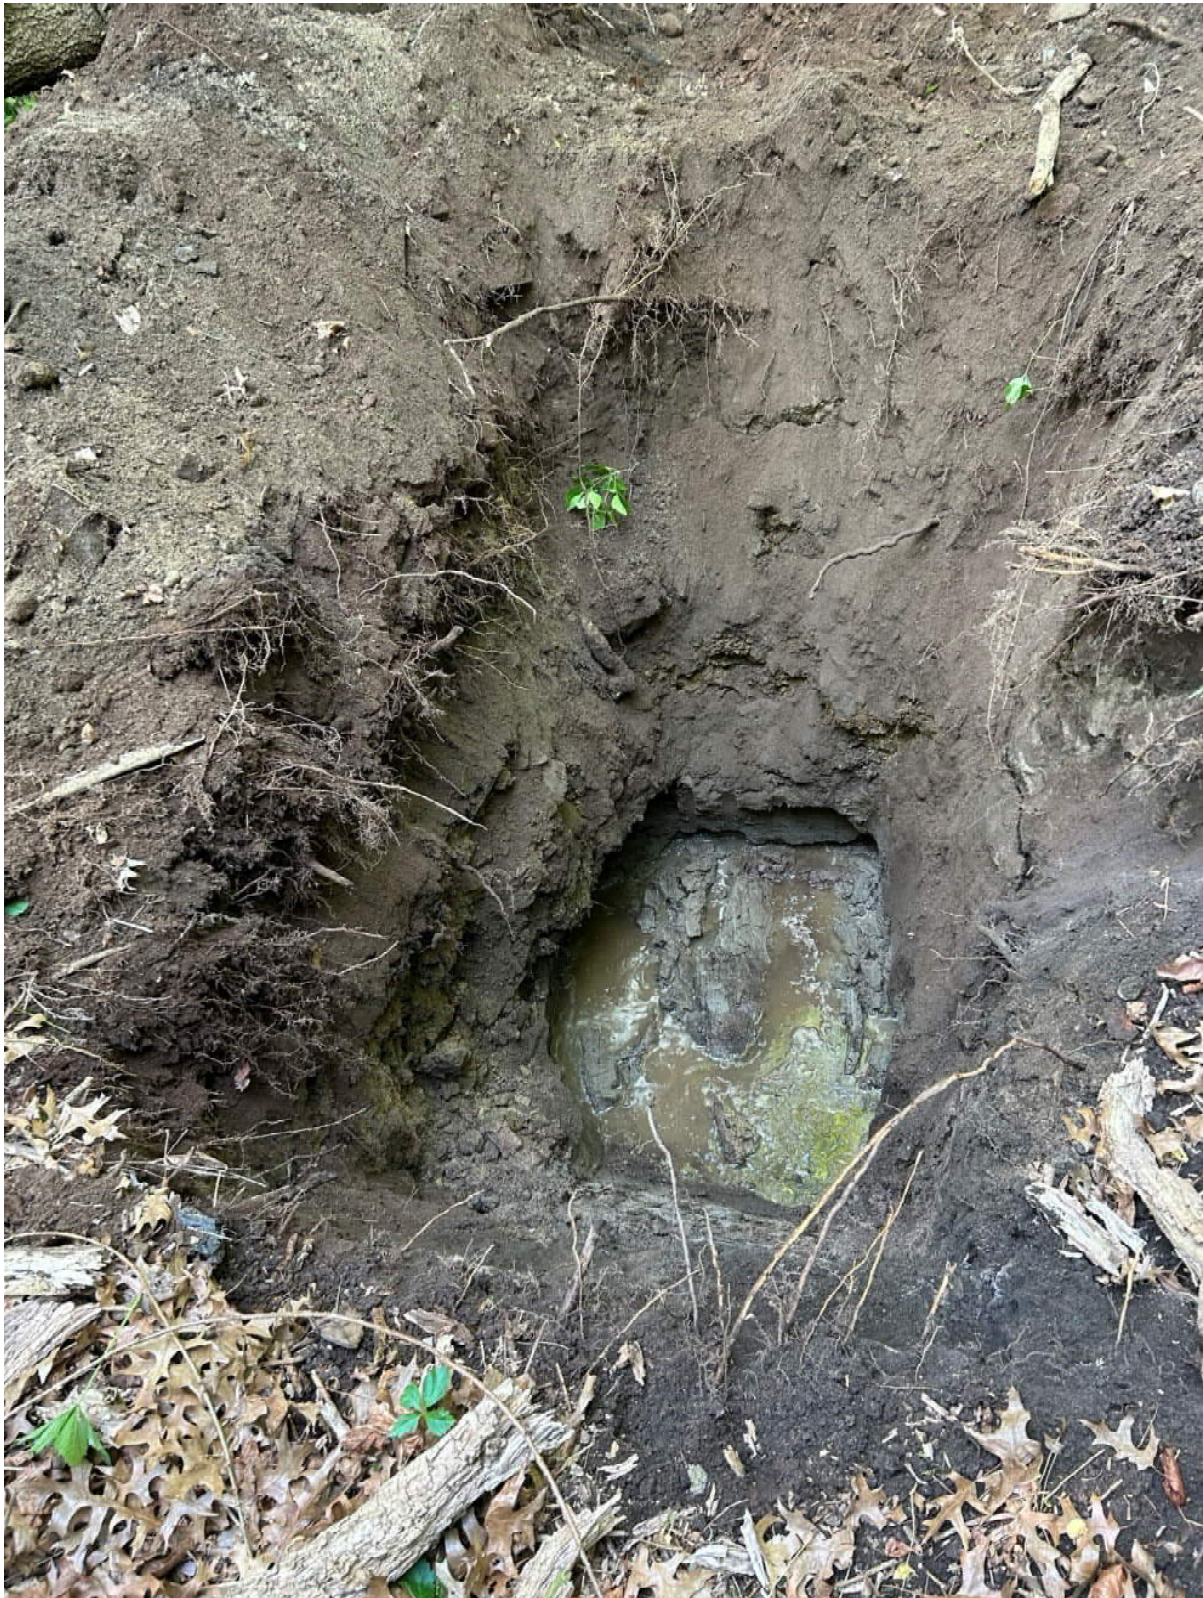
TP-4 with standing water at bottom

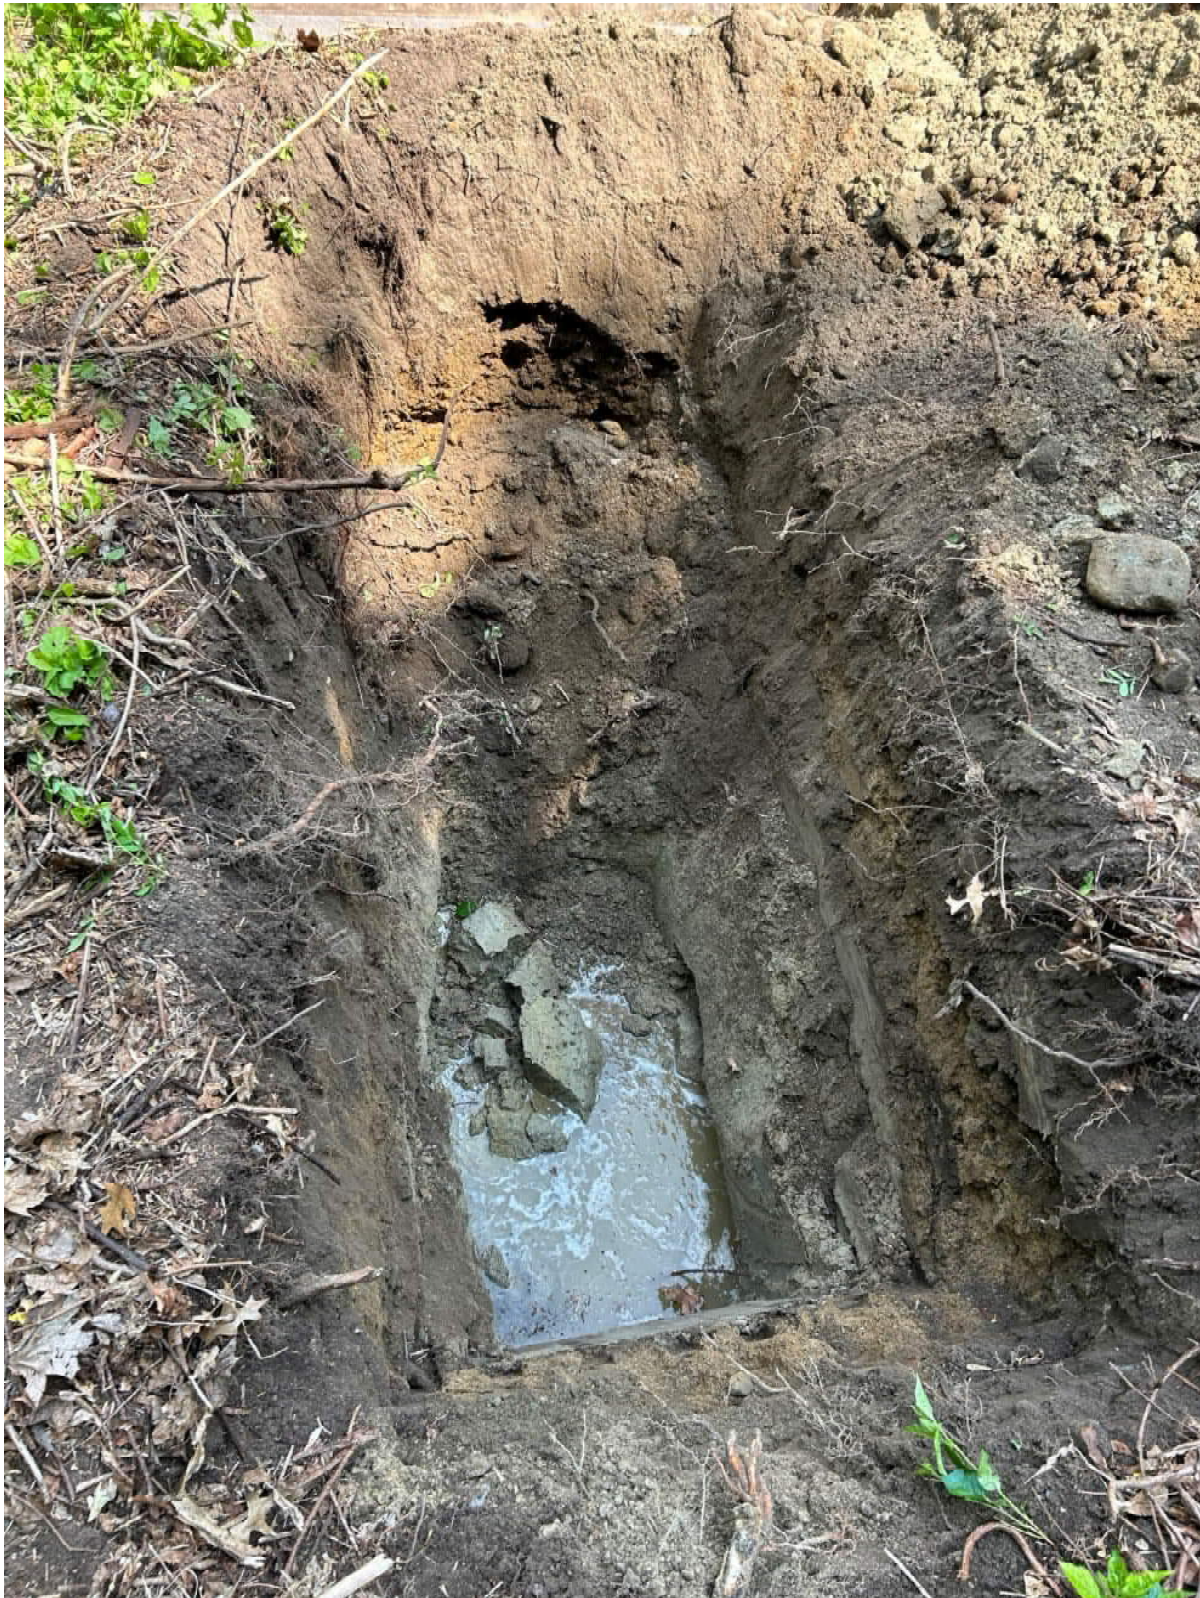
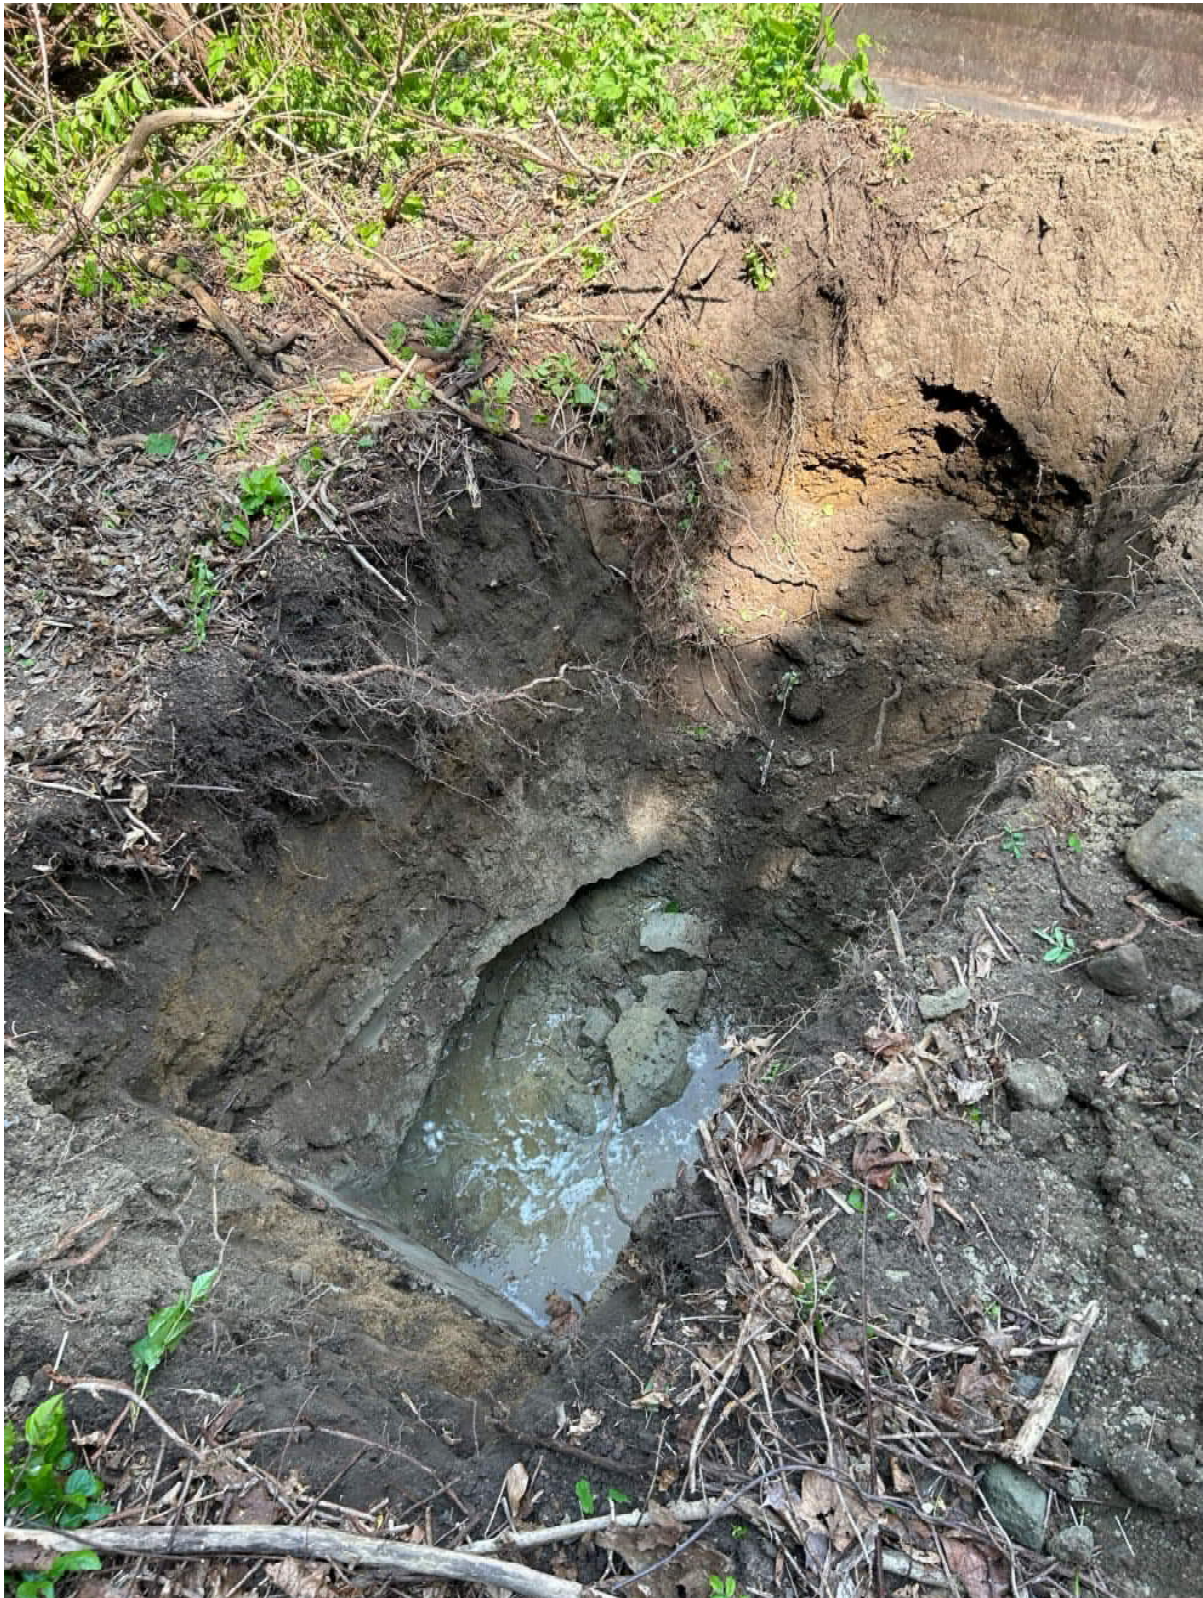
TP-5 with standing water at bottom. Note redoximorphic features on side wall.
